#### 30 Giugno 2017

#### **BLAST vs DAMS**

#### Antonella FRIGERIO, Guido MAZZA'

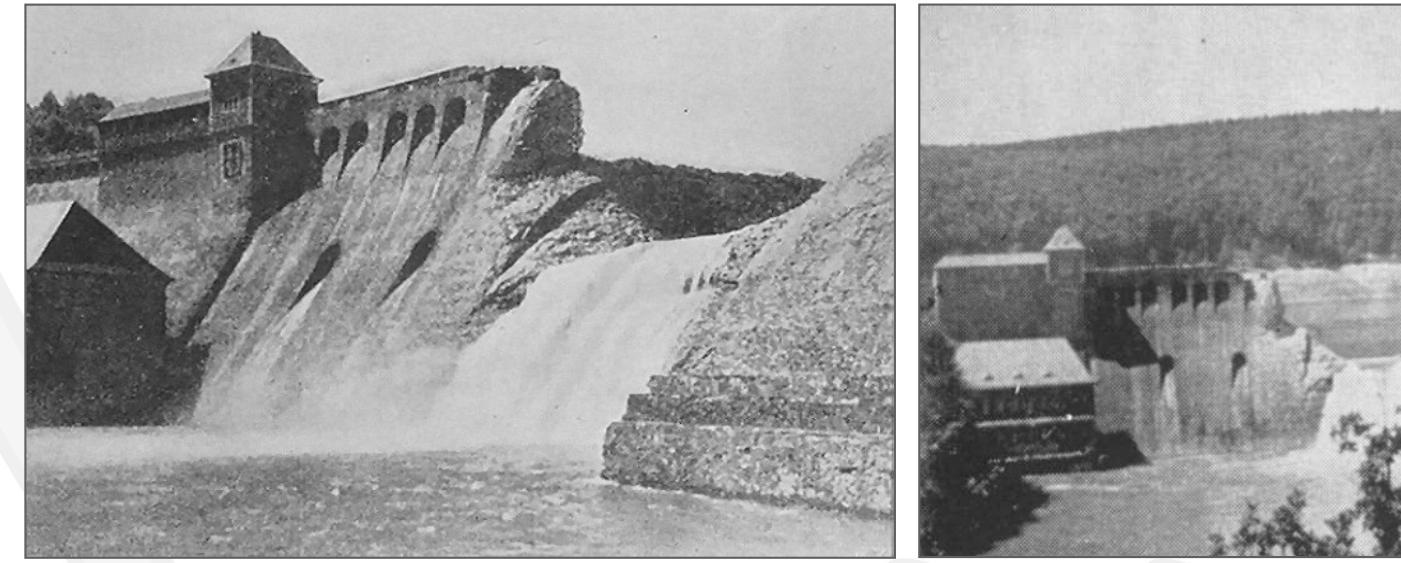
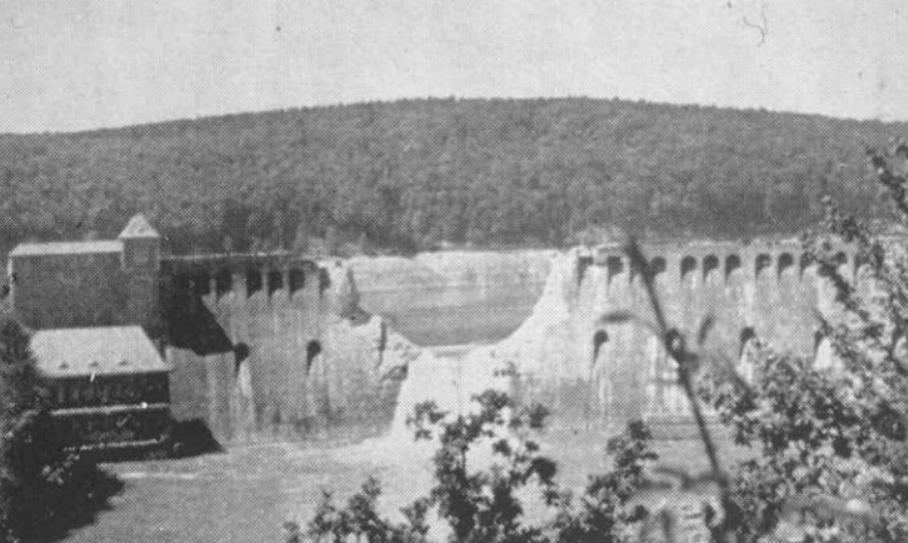
**Eder dam after the RAF** attack in 1943 carried out by means of the so-called "barrel shaped bombs"

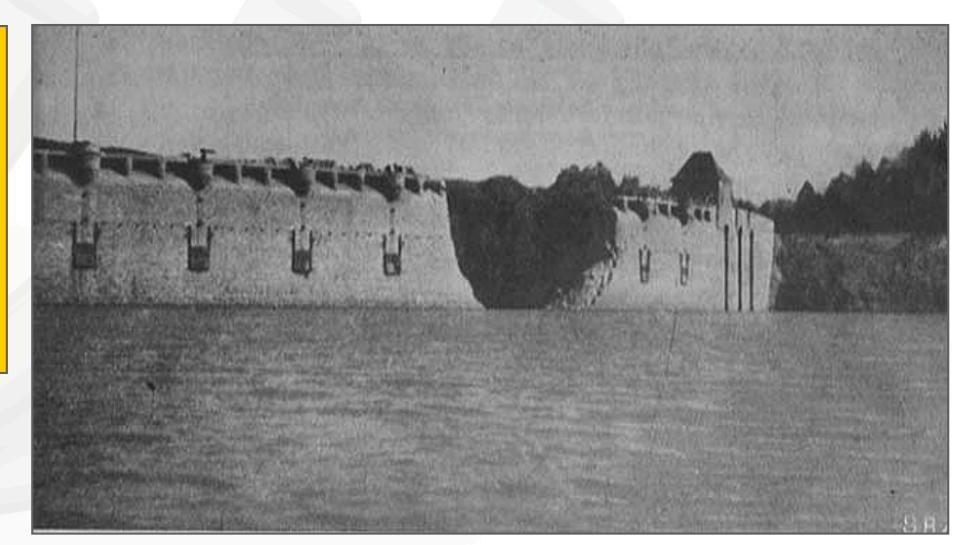
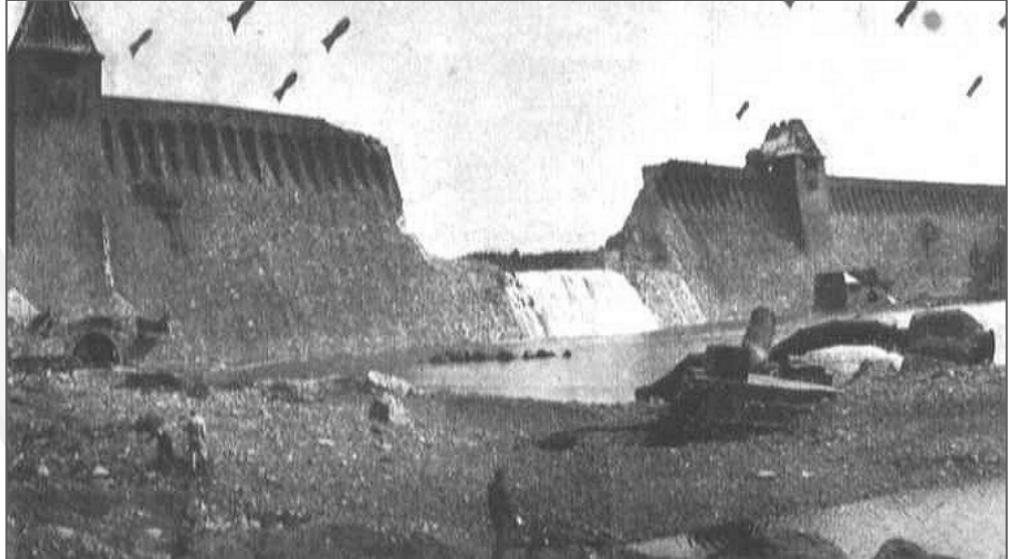
Mohne dam (Germany) after the RAF bombing in 1943 carried out by means of "barrel shaped bombs"

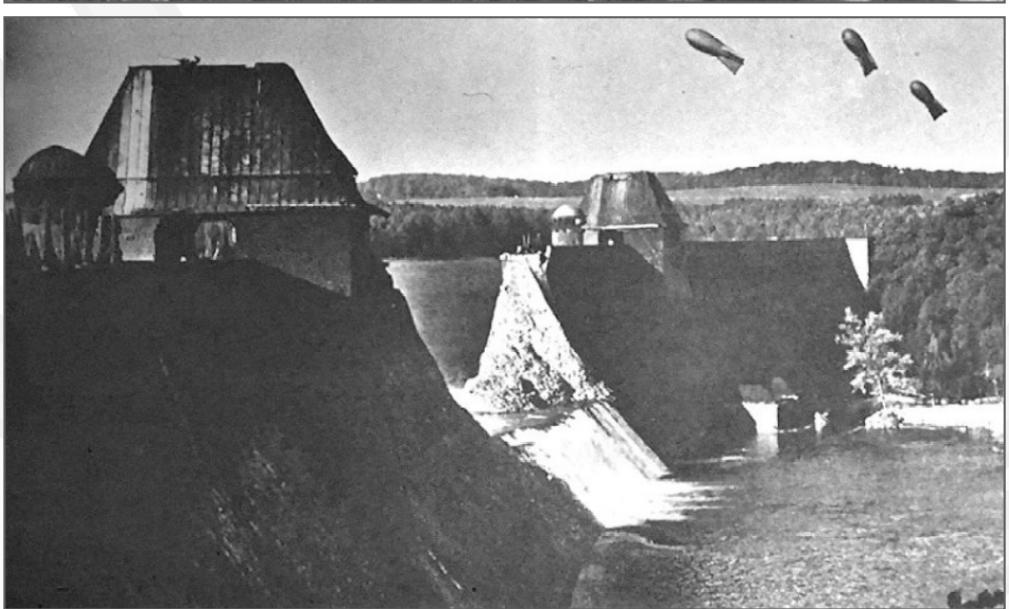
Sorpe dam (Germany) after the RAF bombing in *1943.* The craters caused by bombing can be seen on the downstream dam face. The dam did not fail.

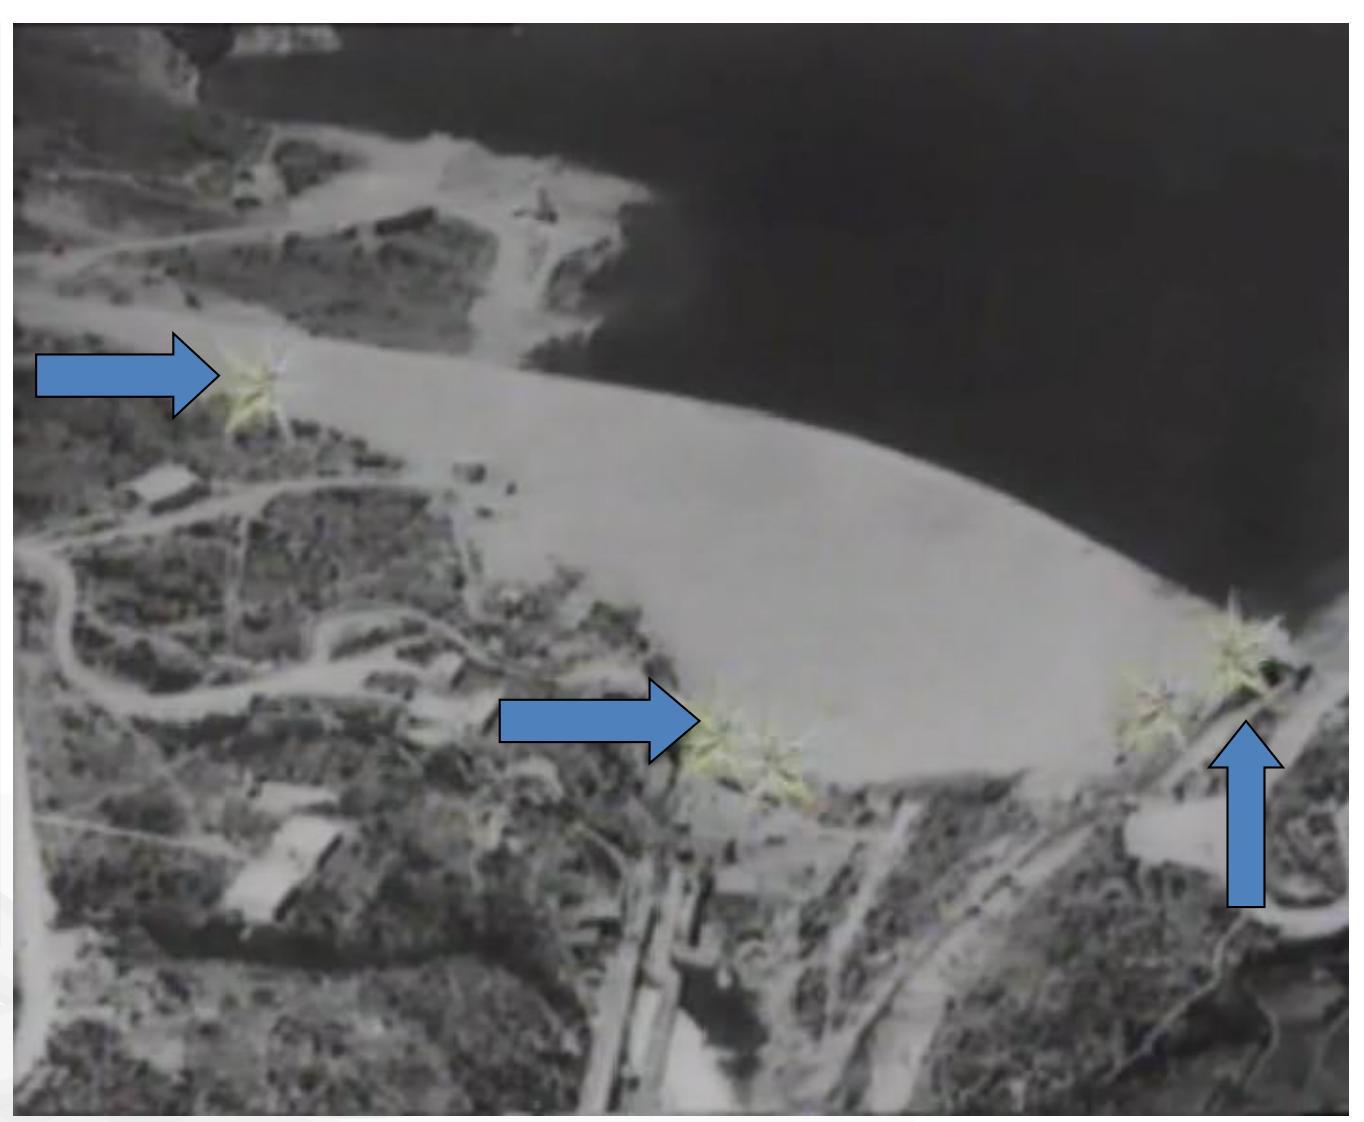
The blasting of Peruca dam caused by the **Serbian troups** in 1993. **Bombs have** been placed at five locations in the inspection gallery.

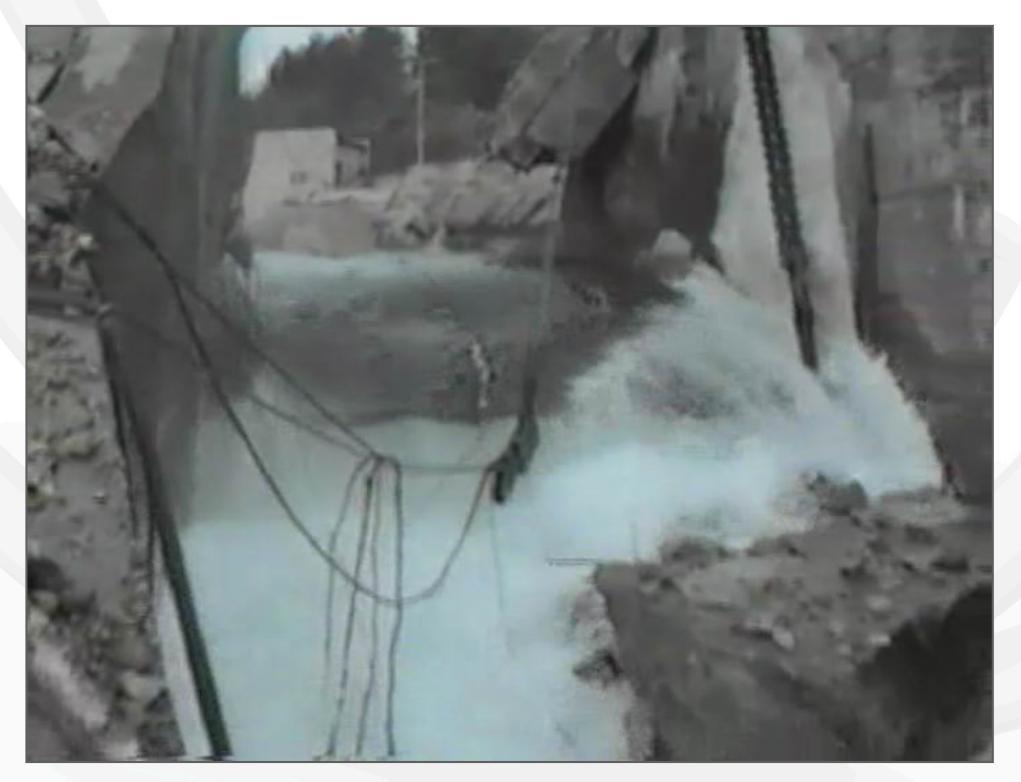
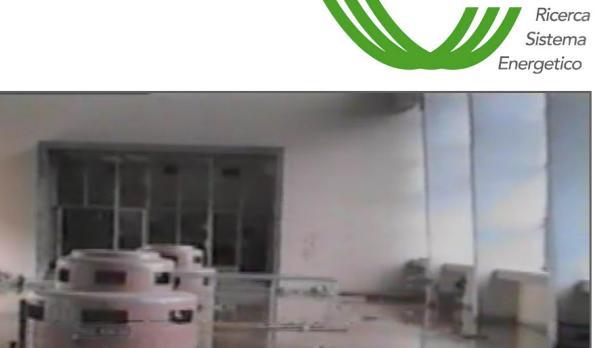
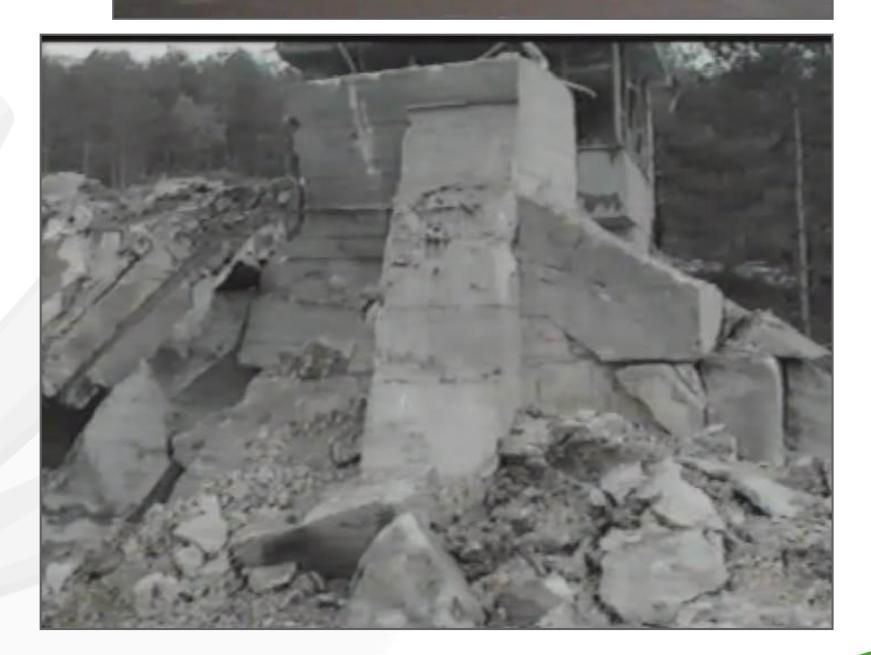
The effects of Peruca dam blasting: the water flew through a breach in the upper part of the dam and flooded the powerhouse and the downstream valley

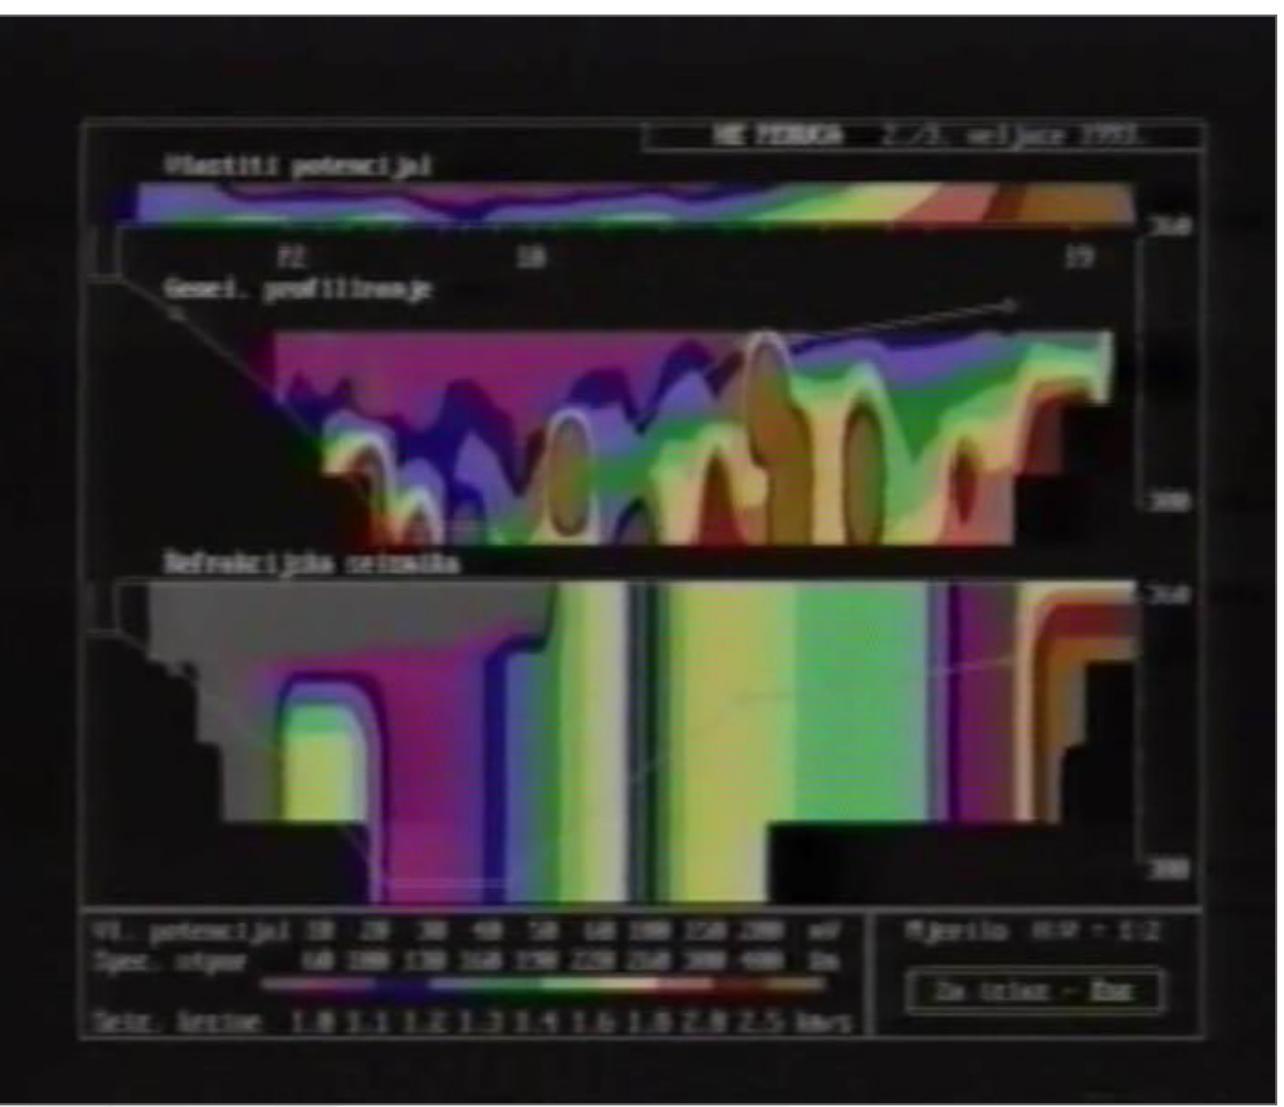
Acustic tomography investigations to check the internal erosion in the dam body caused by blasting and after the rehabilitation works performed by grouting. Peruca dam is presently in operation.

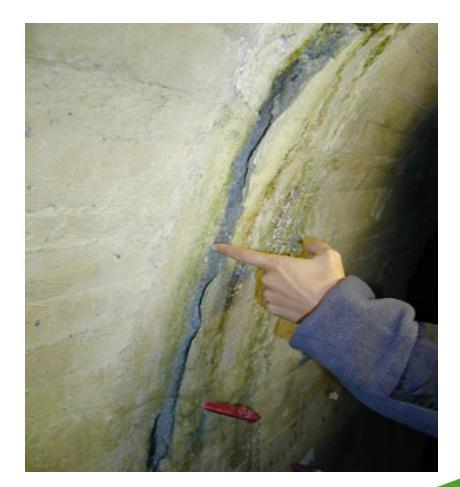
Downstream view

... but since the first fillings the dam deflected upstream and cracks appeared on the downstream face

In 1969 the operational water level was lowered down by the Italian Dam Authorities from 1770 to 1710 m asl
